Firmware Package v5.54/v5.57 Installation Instructions for Axia Element & Fusion Consoles — Release Firmware with Fusion Modules Support

12 February, 2016, Cleveland, Ohio USA

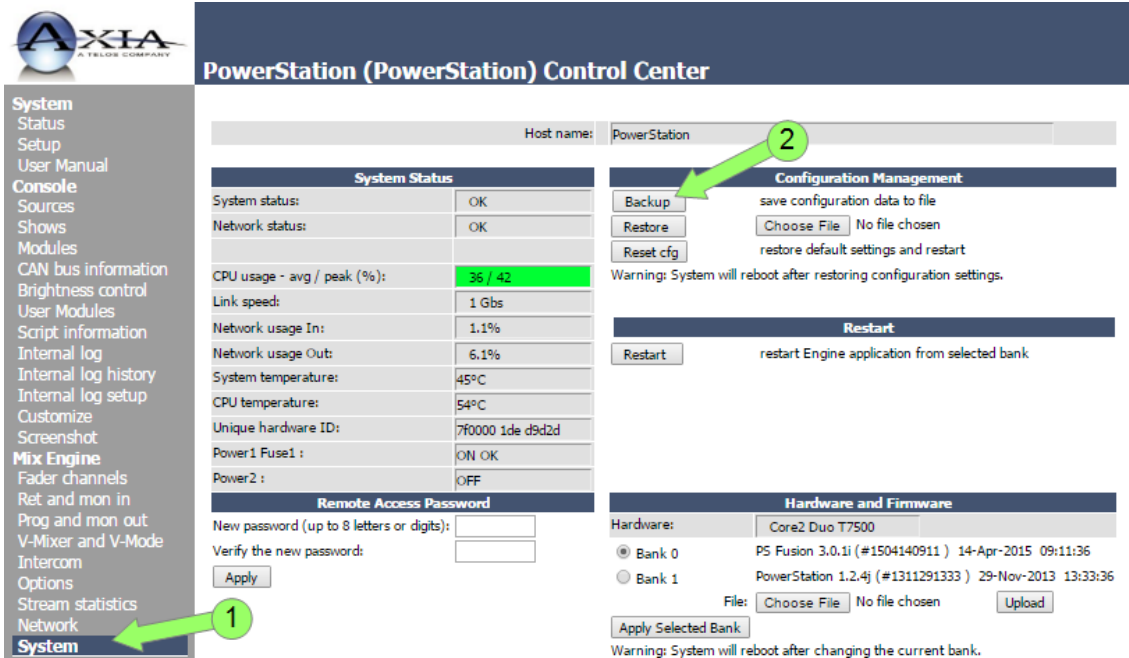
Before updating, backup your configuration. Using your Web browser, enter the IP address of the DSP Engine or PowerStation. When the Control Center screen appears, click on the *System* link (Green Step 1), as shown in this screenshot. If prompted, login with your username and password, and then click on the Backup button (Green Step 2). Store the downloaded file in a safe, convenient location.
